## CAUSES OF TENTING

### Why do tiles tent?

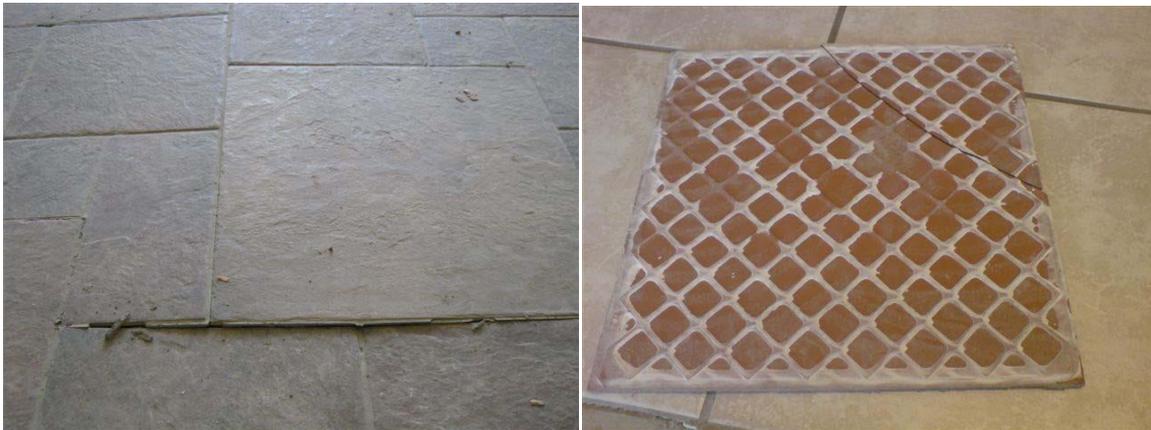
To understand tenting, one must first appreciate that each of the various components within the flooring system are continuously expanding and contracting and that this movement places constant stress upon the tile adhesive to keep the system together. In a successful application, the sum total of the stresses is weaker than the tensile strength (bond strength) of the adhesive. However, in failed system, these stress forces build up over time to eventually exceed the bond strength of the adhesive. The tiles pop up (or tent) because there are actual changes to the linear dimensions such that the length of the tiles is longer than that of the substrate.
